Cooling Towers

Cooling Tower > Motor

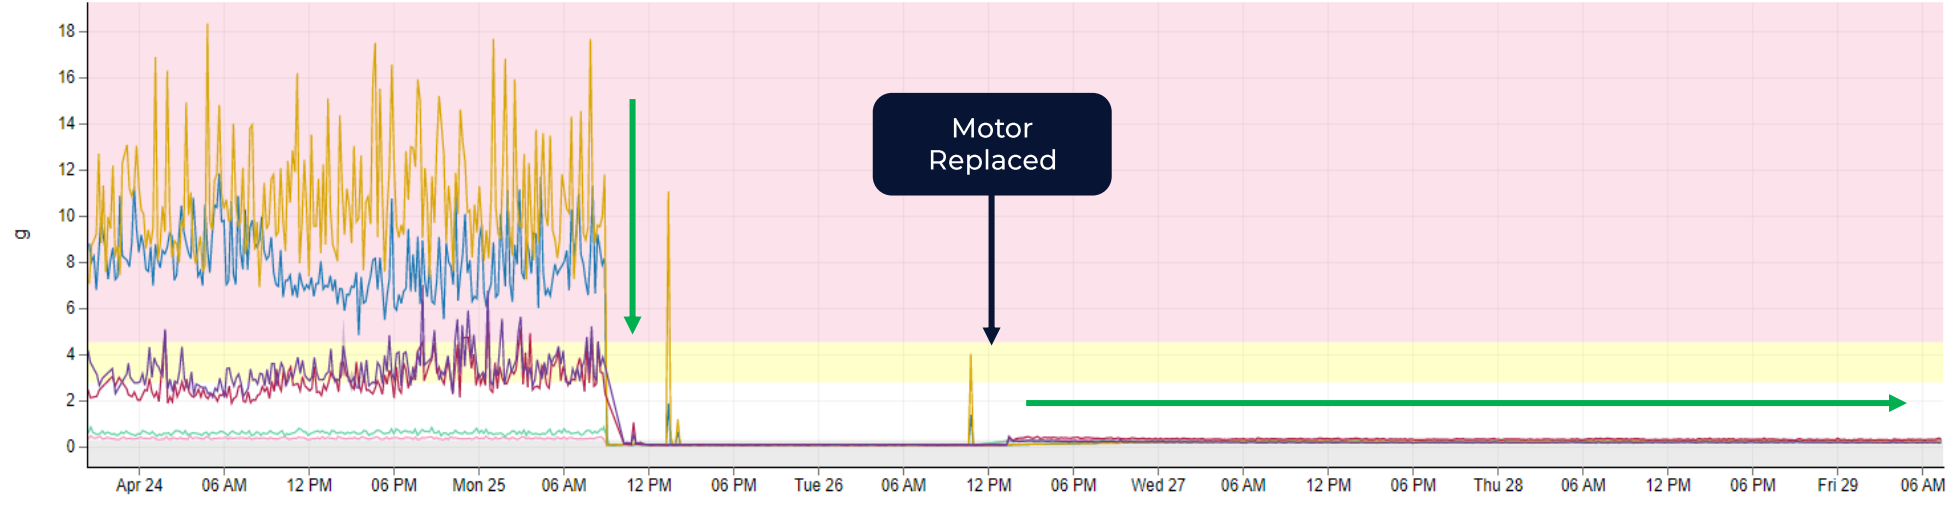
- Stage 2 Bearing Fault (5-10% L10 Life Remaining)

- Outlying vibration when comparing Motor Bearings to similar Cooling Tower Motor
- Raised noise floor between 2-4 kHz

Stage 2 Bearing Fault Vibration Pattern

- Motor replaced. New vibration standard set.

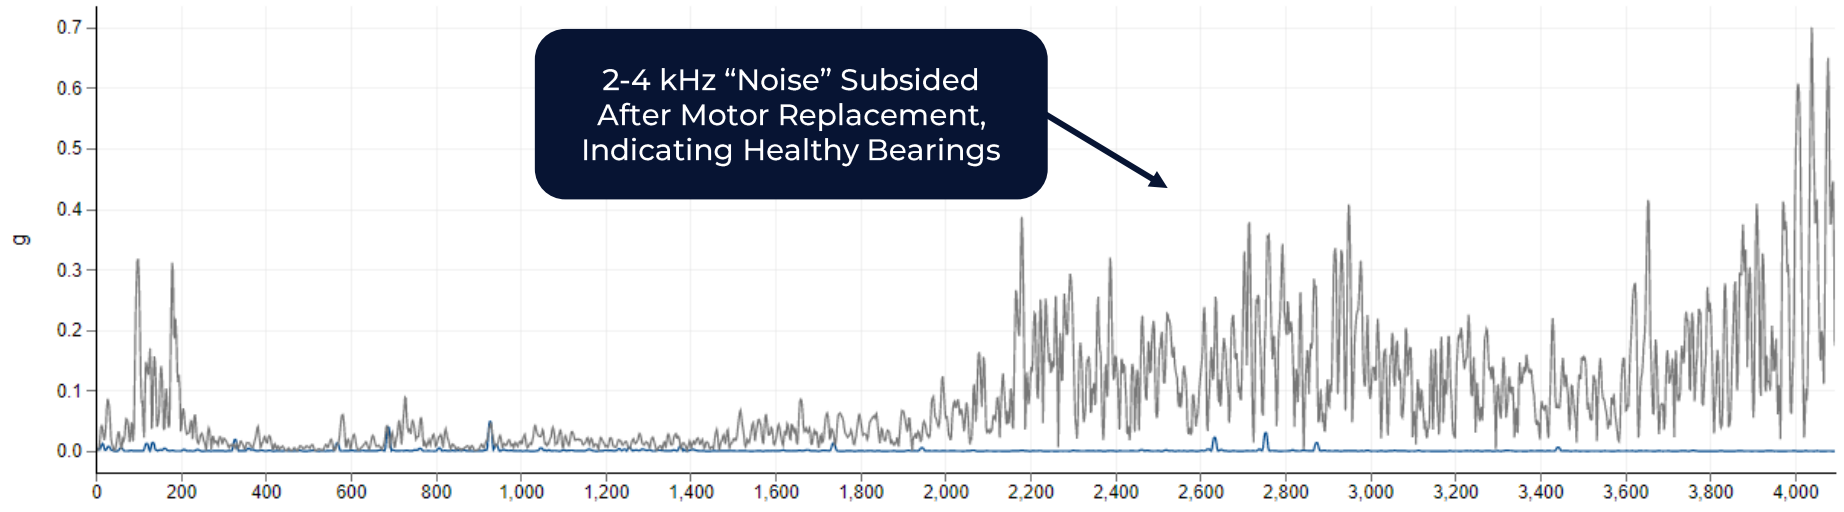
Healthy Bearing Pattern
